# Strength of Lead-free BGA Spheres in High Speed Loading

Keith Sweatman, Shoichi Suenaga, Tetsuro Nishimura, Nihon Superior Co., Ltd, Osaka, Japan

Key words: BGA spheres, impact testing, lead-free solder

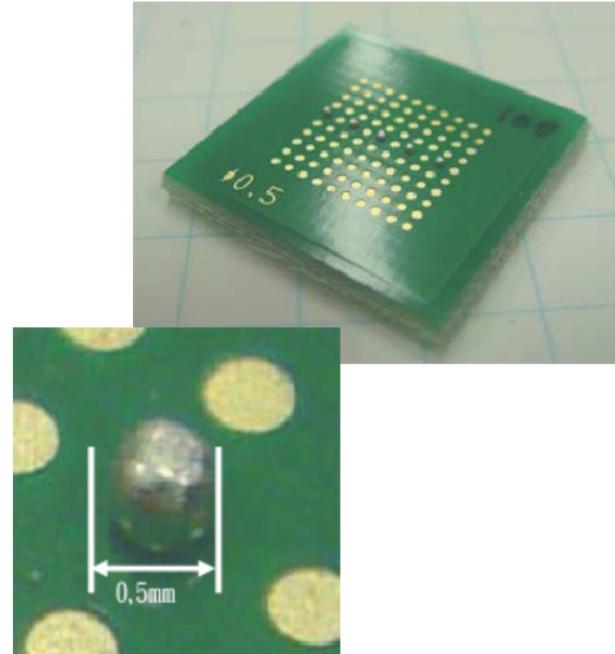
Figure 1. Test Vehicle

Pads for the attachment of the candidate solders were created on copper-clad laminate that had either an OSP or ENIG finish (Table 1) by using solder mask.

Three alloys with the compositions listed in Table 2 were fabricated into 5±0.01mm diameter solder spheres using a liquid drop extrusion method.

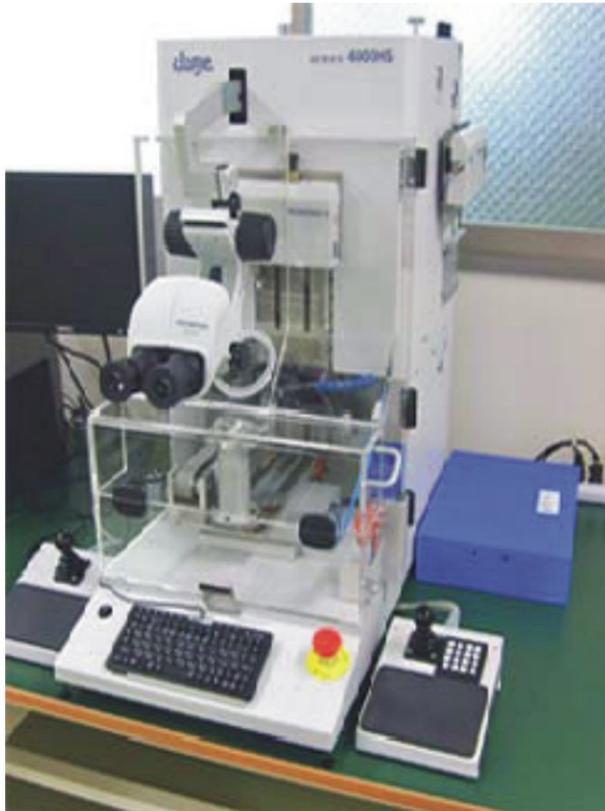
The attachment strength of the BGA spheres to the substrate at different displacement speeds was measured using a Dage "4000HS" Bondtester (Figure 2)

Figure 2. Impact tester

This instrument has the capability of applying a displacement of 10-4000mm/sec in shear and 1-400mm/sec in tension. The configuration of the test is indicated schematically in Figure 3. The method of interpreting the plot of force as a function of the displacement of the solder sphere with respect to the test head is indicated in Figure 4. The work done in fracturing the sphere or detaching it from the substrate, the integral of force with respect to distance, is taken as the fracture energy.

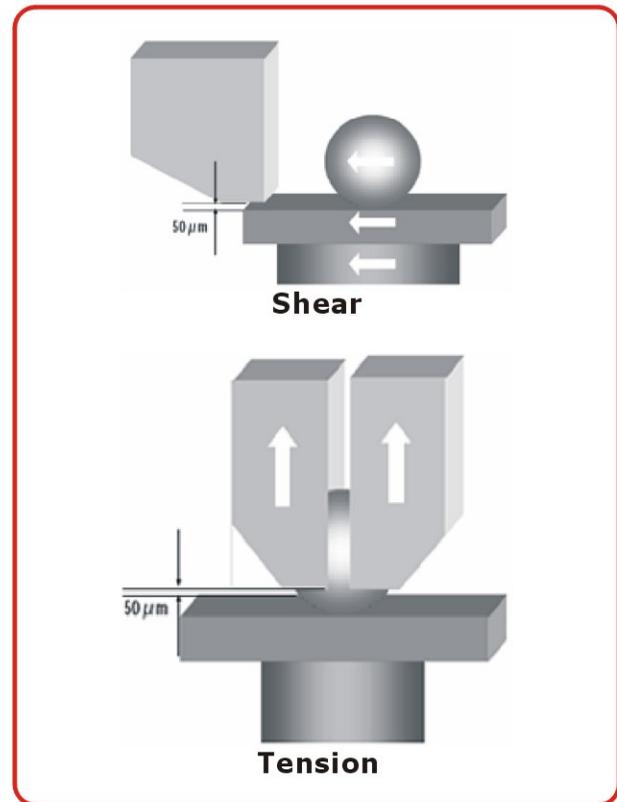
Figure 3. Schematic of test modes

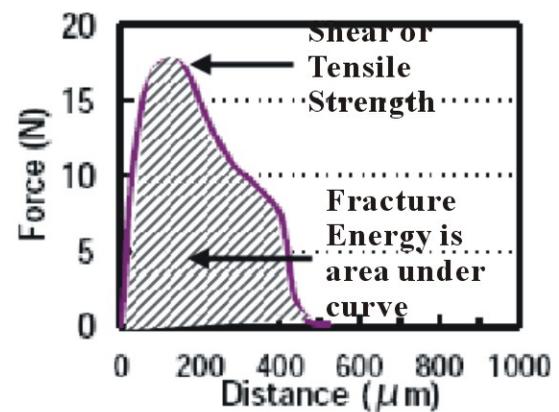
Figure 4. Typical test result.

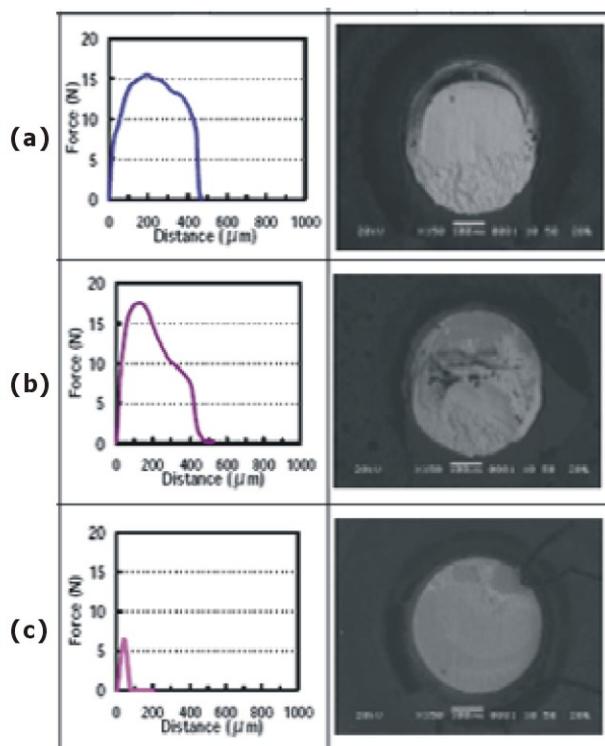
Three general types of failure modes were observed (Figure 5).

In type (a) failure fracture occurs through the body of the solder sphere and the fracture energy is high. The fracture surface indicates the solder has failed in a ductile manner.

In type (c) failure fracture occurs through the intermetallic layer and is brittle in character so that the energy required is small.

In type (b) failure fracture occurs partly through the intermetallic layer and partly through the body of the solder with mixed ductile and brittle character.

Figure 5. Failure modes in impact testing

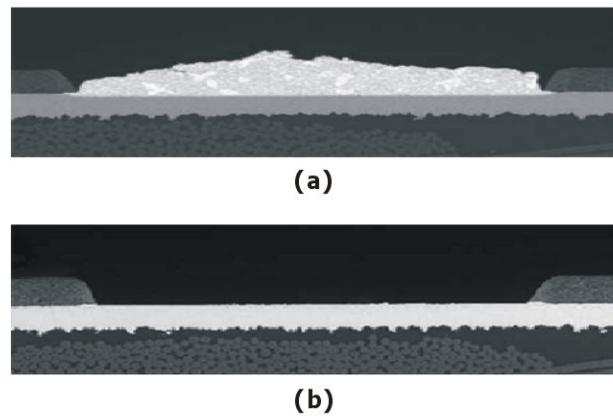
An indication of the extent to which an impact fracture is ductile or brittle is provided by the amount of solder retained on the substrate surface. In Figure 6(a) failure has been ductile with the fracture surface being entirely solder. In Figure 6(b) the failure has been brittle with complete separation of the solder from the substrate at the interface

Figure 6. Solder retention in ductile (a) and brittle (b) failure modes

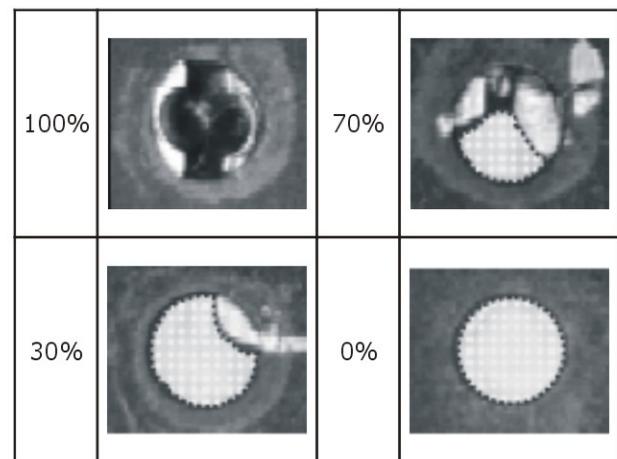
The character of the fracture surfaces of samples tested was quantified by estimating the percentage of the joint area covered by retained solder and examples of the appearance of the fracture surface with various percentages of solder is provided in Figure 7.

Figure 7. Method of quantifying the extent to which fracture is ductile.

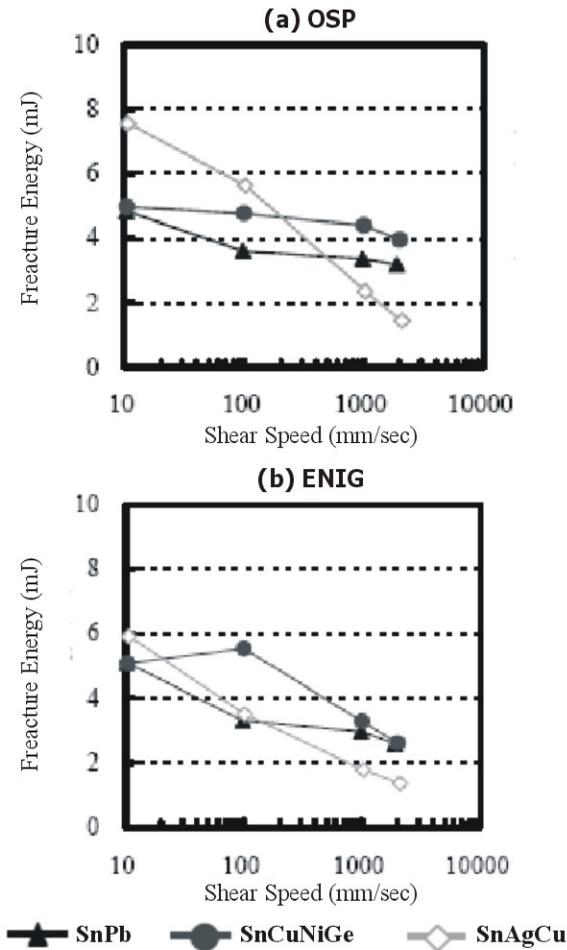
The average fracture energy measured in testing in the shear mode is present in Figure 8.

Figure 8. Average fracture energy as a function of shear speed

In shear testing of solders on a copper/OSP substrate (Figure 8(a)) the SnAgCu alloy has a higher fracture energy than either SnPb or SnCuNiGe at shear speeds up to 100mm/sec but at higher speeds the ranking is reversed. At 2000mm/sec the SnCuNiGe alloy has a fracture energy nearly four times greater than the SnAgCu and is a little higher than that of SnPb.

On the copper/ENIG substrate (Figure 8(b)) the SnAgCu advantage largely disappears and fracture energy falls as the shear speed increases so that at 2000mm/sec it is about half that of the SnCuNiGe and SnPb.

On ENIG (Figure 8(b)) the fracture energy of the SnPb follows a similar trend to that on OSP. The failure strength of SnCuNiGe starts to fall away after 10mm/sec while that of SnAgCu starts to fall away after reaching a peak at 100mm/sec. The fracture energy of all alloys falls steadily to very low values with increasing shear rate.

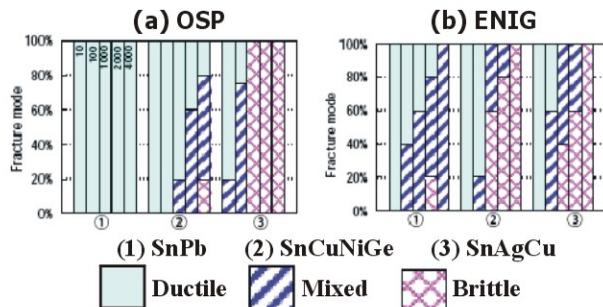
Figure 9. Fracture mode as a function of shear speed for each test piece

An indication of the trend of failure mode in shear testing is given in the summary of the fracture types for each of the five samples tested at each shear speed in Figure 9.

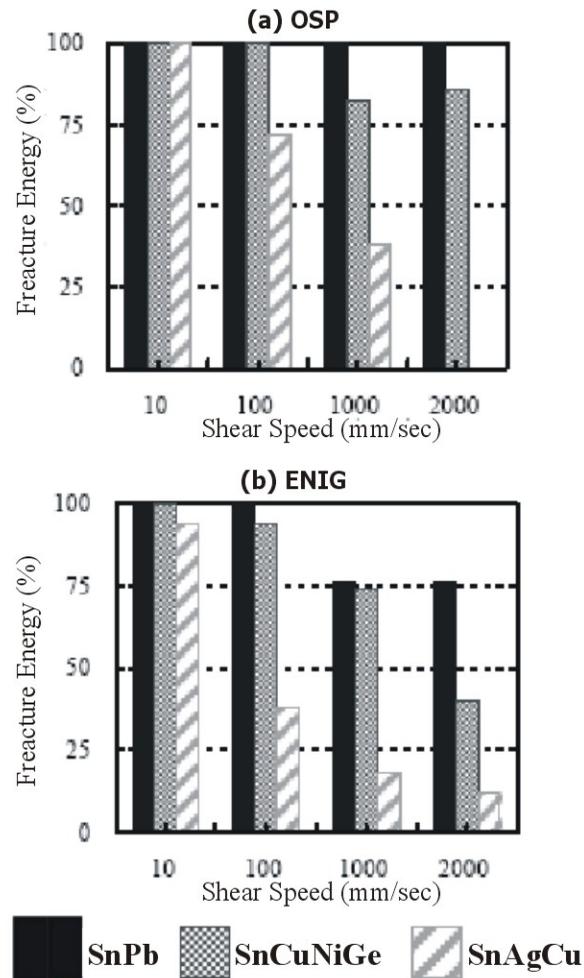
indicating the extent to which the fracture mode is ductile, is plotted in Figure 10 for shear speeds up to 2000mm/sec.

Figure 10. Proportion of Ductile Fracture

The trend towards brittle fracture in the SnAgCu even at lower shear speeds and on both substrates is apparent in the higher incidence of mixed and brittle fracture modes (Figure 10).

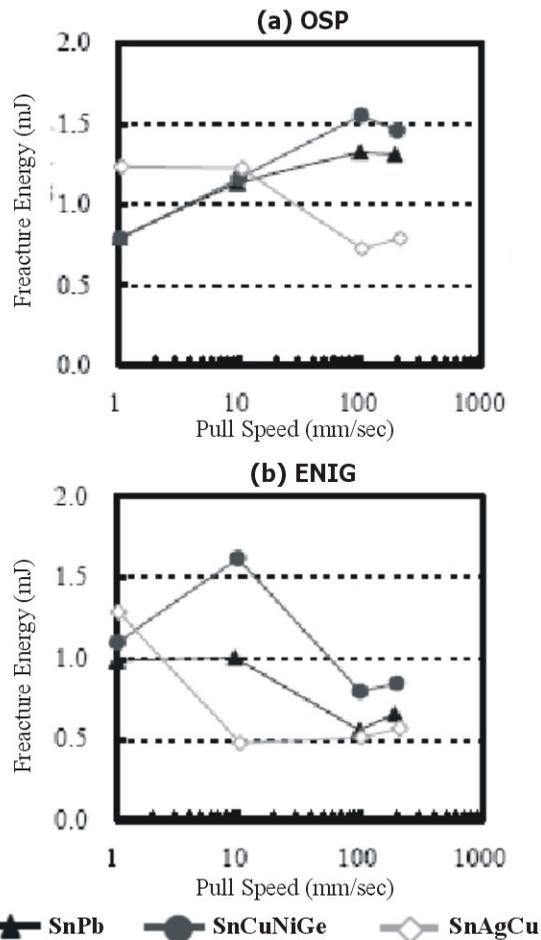
The measured fracture energy in the tensile mode is presented in Figures 11.

Figure 11. Fracture energy as a function of pull speed

The trends in pull testing are similar (Figures 11, 12, 13)

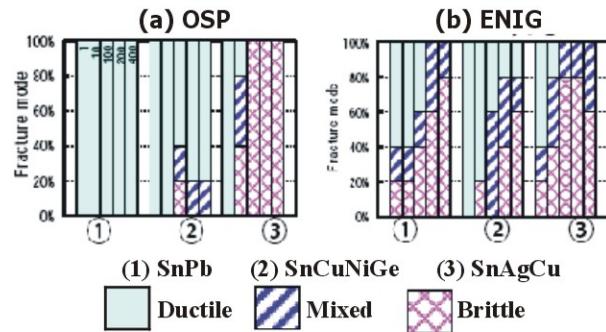
The character of the fracture surfaces of each of the five samples tested at each pull speed is summarised in Figure 12.

Figure 12. Fracture mode as a function of pull speed for each test piece

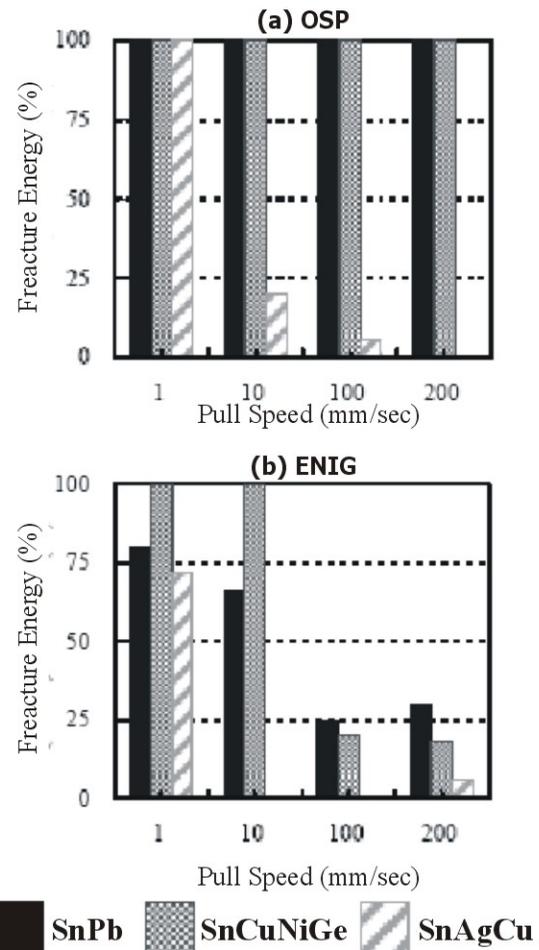
The percentages of solder in the fracture surface is plotted in Figure 13 for pull speeds of up to 200mm/sec.

Figure 13. Proportion of Ductile Fracture

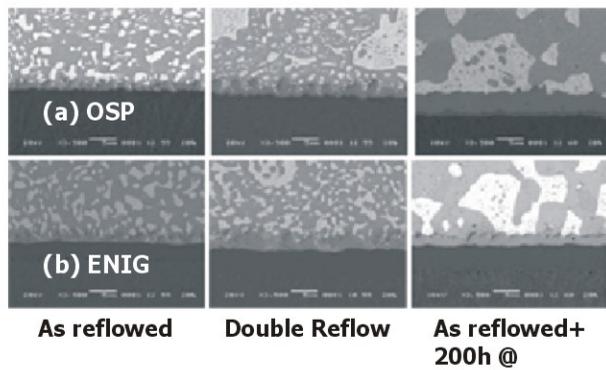
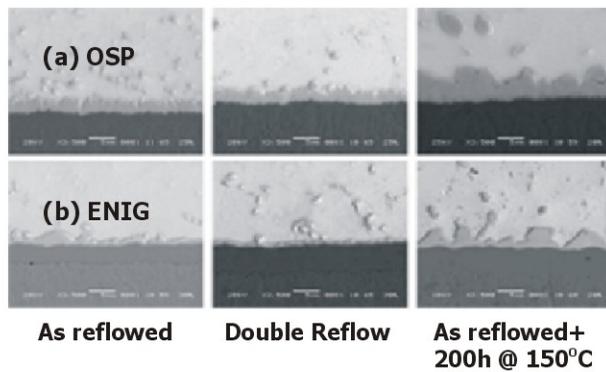
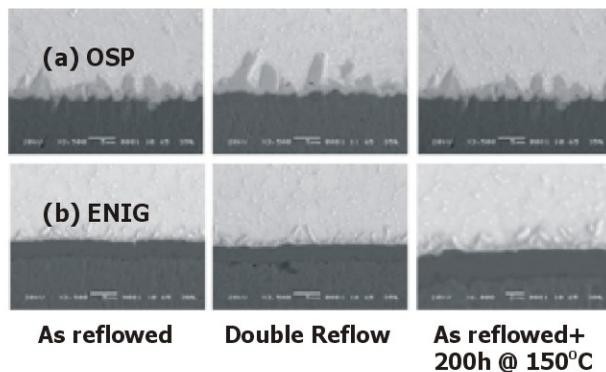
The effect of ageing on the microstructure of the alloy/substrate combinations is presented in Figures 14, 15 and 16

Figure 14. Effect of ageing on SnPb

Figure 15. Effect of ageing on SnCuNiGe

Figure 16. Effect of ageing on SnAgCu

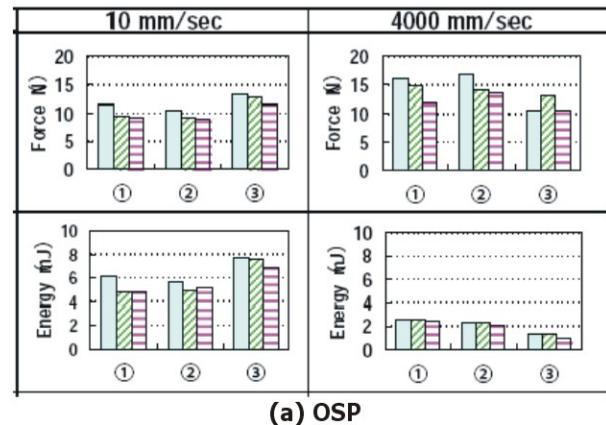
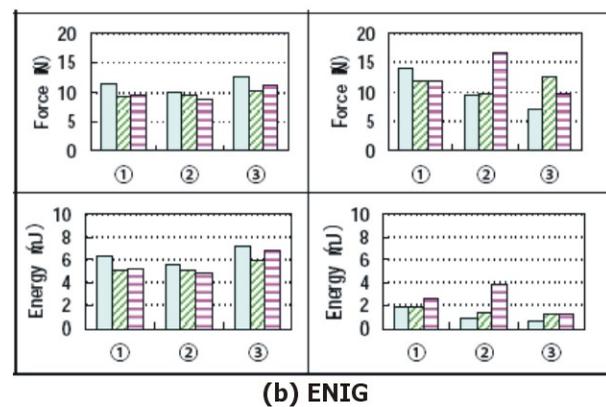
The effect of ageing on strength and fracture energy as a function of finish at high and low rates of shear and pull is presented in Figures 17 and 18.

Figure 17. Effect of ageing on performance in shear

The additional thermal excursions reduced the strength and fracture energy in shear and tension of all alloys on OSP with the 200 hours at 150°C having the greatest negative effect (Figures 17(a) and 18(a)). An exception was SnAgCu on OSP tested at 4000mm/sec where the second reflow resulted in the greatest fracture energy but it is difficult to reconcile that with the thicker intermetallic apparent in the cross-section in Figure 16(a). The fact that a similar effect occurred in tension on OSP (Figure 17(a)) suggests that indeed the second reflow has somehow increased the toughness of the joint.

On ENIG there is not a consistent trend of deterioration of strength and fracture energy with increasing thermal exposure. In fact the 200 hour ageing substantially increased strength and toughness of SnCuNiGe in shear at 4000mm/sec despite substantial increase in thickness and columnar character of the interfacial intermetallic (Figure 15(b)). There was a similar although smaller beneficial effect of the 200 hour ageing on the fracture energy of SnPb. In tension the trend of deterioration of strength and fracture energy is consistent across all alloys and pull speeds on an OSP substrate with the 200 hour ageing having the greatest negative effect. On ENIG, the strength of the SnCuNiGe joint seems unaffected by the second reflow or the 200 hour ageing while the strength and fracture energy of the SnAgCu alloy is substantially reduced even at a pull speed of only 1mm/sec.

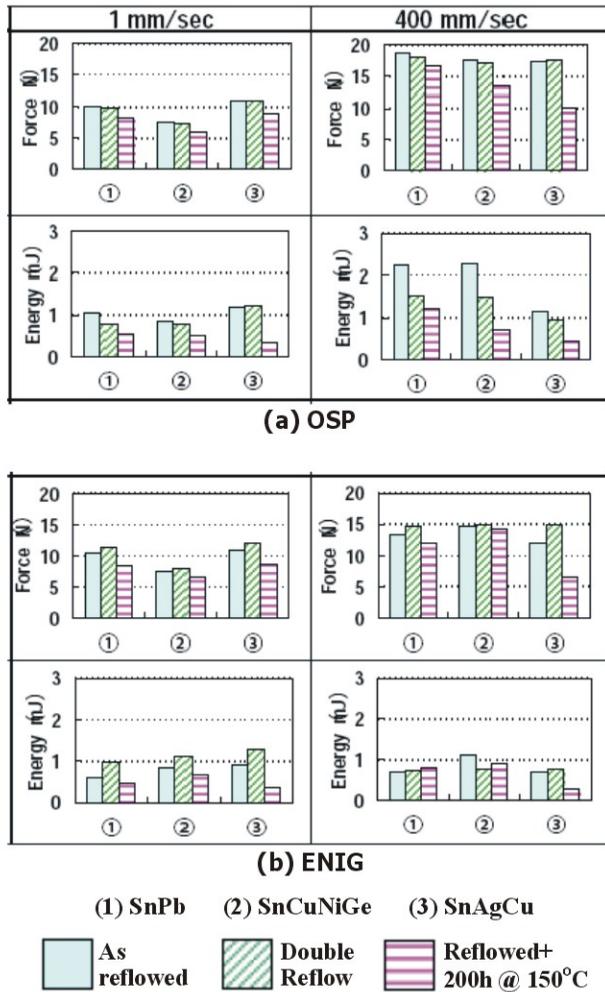
Figure 18. Effect of ageing on performance in pull test

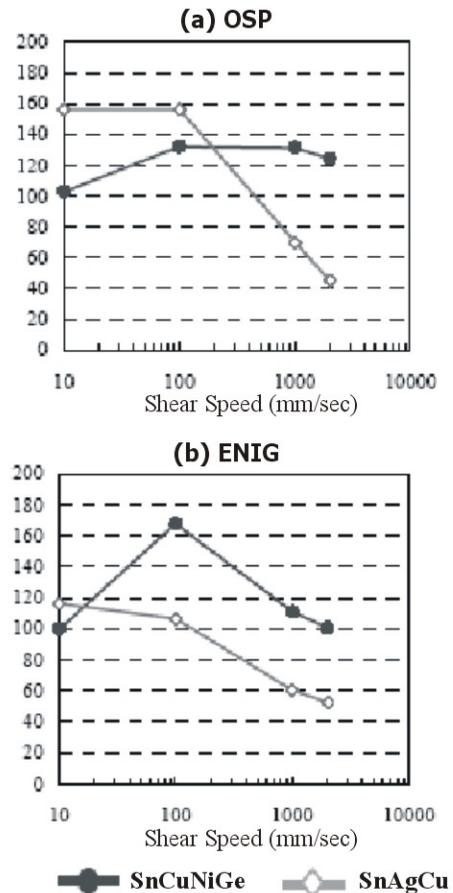
In Figure 19 the average fracture energies in shear testing have been replotted on the basis that the fracture energy of SnCuNiGe at 10mm/sec is 100%.

Figure 19. Variation in shear fracture energy from that of SnCuNiGe at 10mm/sec

On a copper/OSP substrate the measured fracture energy of the SnCuNiGe solder actually increases slightly with shear speed while that of SnAgCu falls off rapidly at speeds above 100mm/sec. On a copper/ENIG substrate the SnCuNiGe alloy maintains a substantial advantage in fracture energy at shear speeds above 10mm/sec.

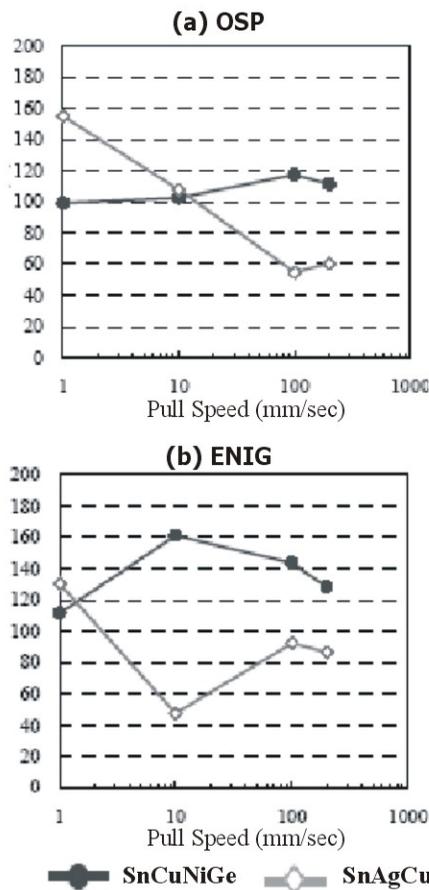
In Figure 20 the average fracture energies in tensile testing have been replotted on a similar basis and the trends is similarly of higher fracture energy on OSP at pull speeds greater than 10mm/sec and on ENIG at all pull speeds greater than 1mm/sec. Some insight into the microstructural features that contribute to the measured fracture energies is

Figure 20. Variation from SnPb of pull test results on ENIG

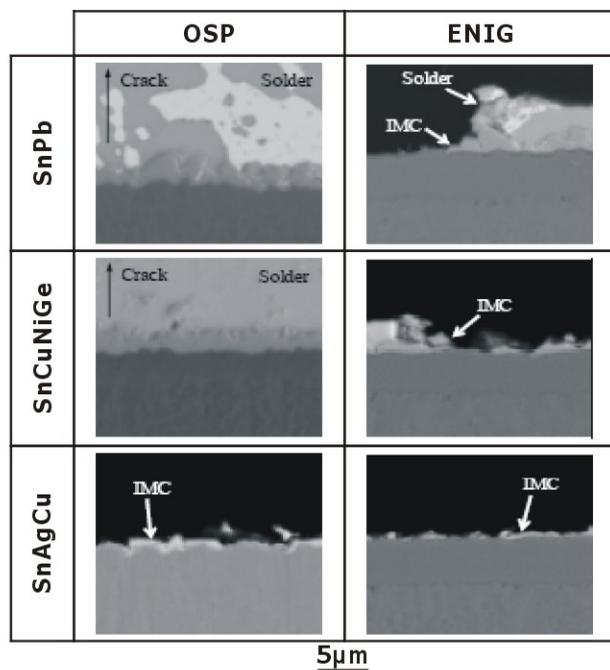
provided by cross-sections of the fractured test pieces (Figure 21 and 22)

Figure 21. Cross-sections of Joints after shear testing

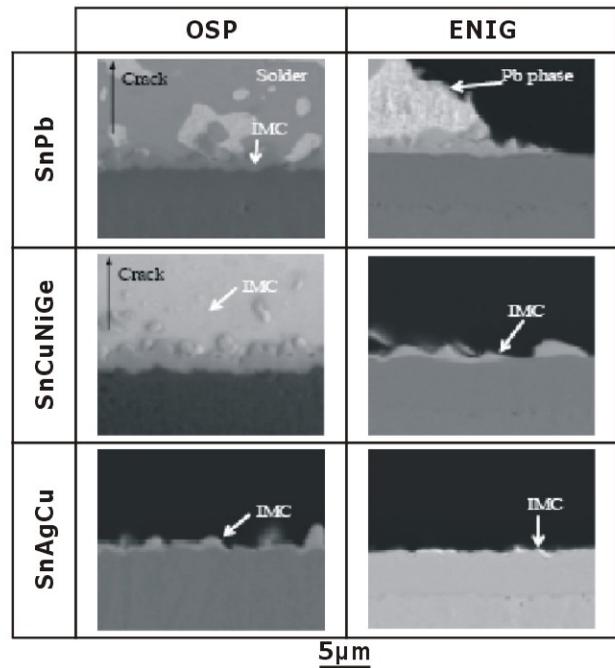
Figure 22. Cross-sections of joints after tensile testing

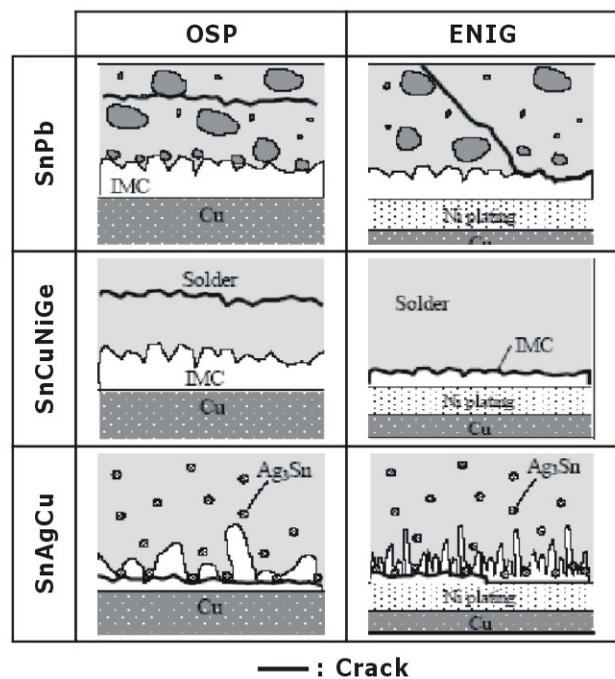
On the basis of these observations the inference can be made that the crack propagation pathways are as indicated schematically in Figure 23.

Figure 23. Typical crack pathways in impact loading
